SAFETY RECALL

Turn Signal Lever Latch - Equipment

Reference: A2B

Parts Recalled MOPAR STEERING COLUMN CONTROL MODULE PART NUMBER 68545657AA for 2019-2023 (DT) RAM 1500 Pickup

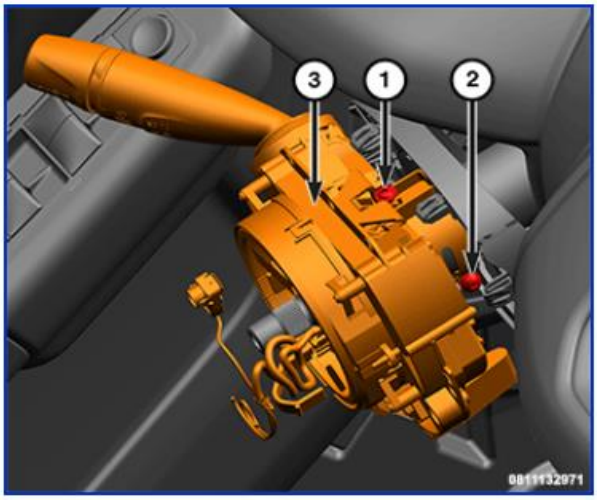
Figure 3 – SCCM Fasteners

1 - Fastener

1. Place the front wheels in the straight-ahead position and inhibit the steering column shaft from rotation.
2. Extend the steering column to the fully extended position and lower it to its lowest (down) position.
3. Disconnect and isolate the negative battery cable(s) (Refer to 08 - Electrical/Battery System/Standard Procedure).
4. Remove the steering wheel (Refer to 19 - Steering/Column/WHEEL, Steering/Removal and Installation).
5. Remove the outer shroud from the steering column (Refer to 19 - Steering/Column/SHROUD, Steering Column/Removal and Installation).
6. Remove the fasteners (1) from the SCCM (Figure 3).
7. Release the integral retainers for the inner shroud and push the inner shroud toward the instrument panel as far as it will go.

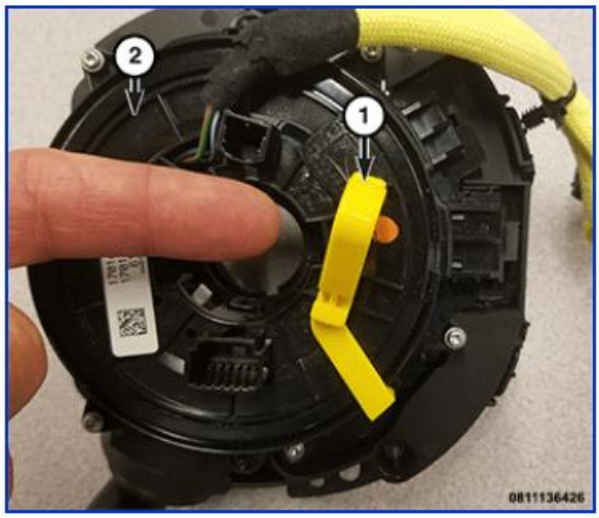
Figure 4 – SCCM Fasteners

1 - Attachment Fastener
2 - Clamp Fastener
3 - SCCM

8. Loosen the centering attachment fastener (1) on the top, rear of the SCCM. Do not remove the fastener completely (Figure 4).

9. Loosen the clamp fastener (2) to allow the SCCM to be removed. Do not remove the fastener completely (Figure 4).

10. Pull the SCCM (3) away from the steering column inner shroud far enough to disconnect the instrument panel wire harness connectors (Figure 4).

11. Remove the SCCM from the steering column.

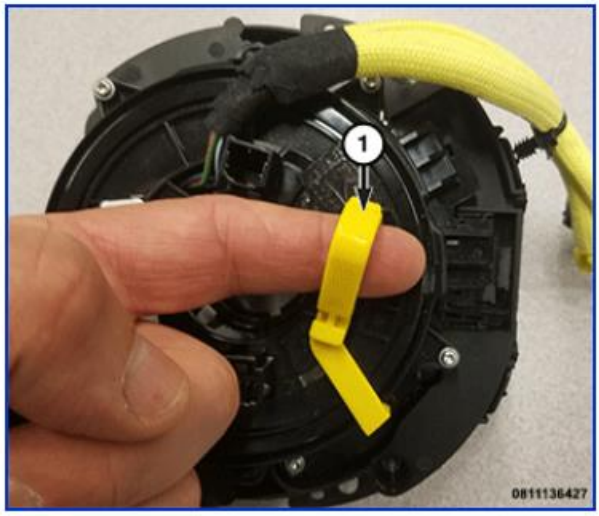
Figure 5 – SCCM

1 - Lock
2 - Clockspring Rotor

- A service replacement SCCM is shipped with the clockspring centered and with a molded plastic lock (1) installed. This lock should not be broken off until the SCCM has been installed on the steering column (Figure 5).
- Tighten the fasteners securely.
- Engage the integral inner shroud retainers with the SCCM. Be certain all integral inner shroud retainers are engaged with the SCCM.
- If a new SCCM is being installed, break off the plastic lock (1) that secures the clockspring rotor (2) to the SCCM housing to maintain clockspring centering (Figure 5).

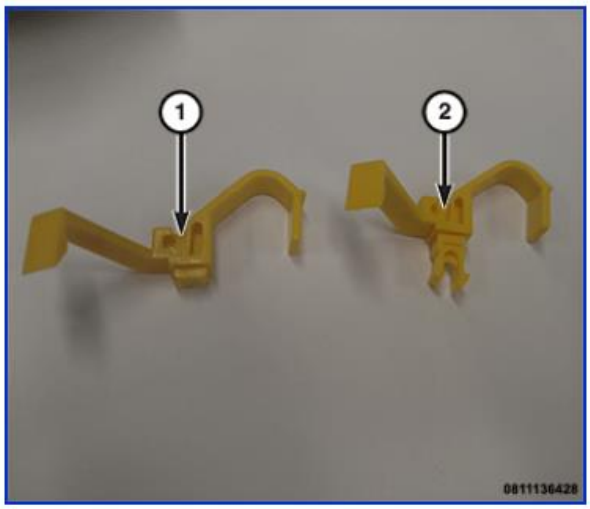
Figure 6 – SCCM Lock

1 - Lock

- Rotate the lock (1) towards the center of the SCCM to break it off in the SCCM housing (Figure 6).
