STAR ONLINE PUBLICATION

Case Number: S1902000008 Rev. B

Symptom/Vehicle Issue: Air Suspension Compressor Module Assembly Replacement.

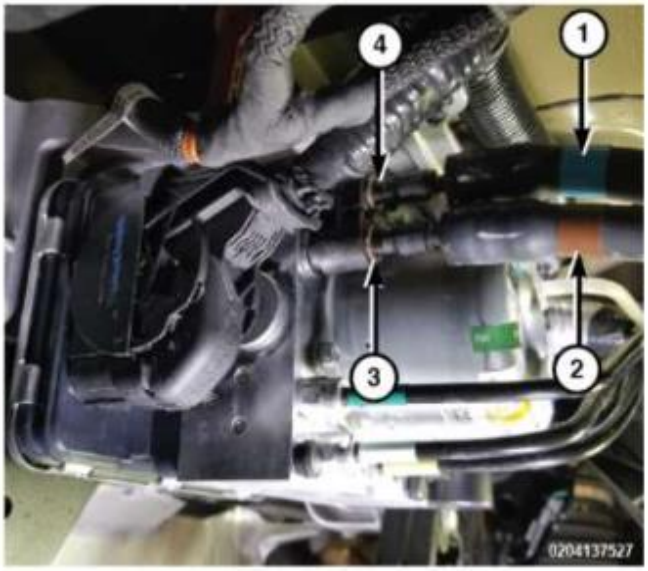
When servicing an Air Suspension Control Module assembly do not remove this fastener (circled in RED above). If the plastic fitting is removed from the compressor assembly an internal leak may occur resulting in nitrogen loss.
