SAFETY RECALL
NORTH AMERICA
Turn Signal Lever Latch

Reference: A1B / Transport Canada 2024-576

2023-2024 (DT) RAM 1500 Pickup

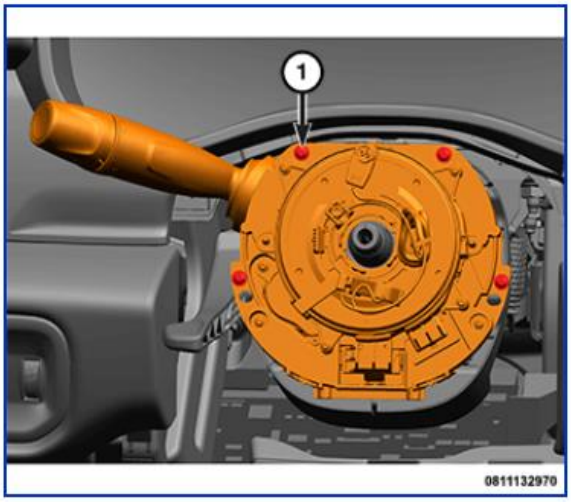
Figure 1 - SCCM Fasteners

1 - Fastener

1. Place the front wheels in the straight-ahead position and inhibit the steering column shaft from rotation.
2. Extend the steering column to the fully extended position and lower it to its lowest (down) position.
3. Disconnect and isolate the negative battery cable(s) (In Service Library refer to 08 - Electrical/Battery System/Standard Procedure).
4. Remove the steering wheel (In Service Library refer to 19 - Steering/Column/WHEEL, Steering/Removal and Installation).
5. Remove the outer shroud from the steering column (Refer to 19 - Steering/Column/SHROUD, Steering Column/Removal and Installation).
6. Remove the fasteners (1) from the SCCM (Figure 1).
7. Release the integral retainers for the inner shroud and push the inner shroud toward the instrument panel as far as it will go.

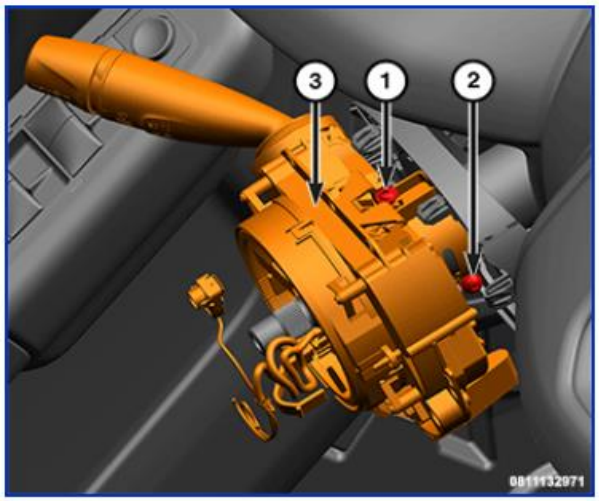
Figure 2 - SCCM Fasteners

1 - Fastener
2 - Clamp Fastener
3 - SCCM

8. Loosen the centering attachment fastener (1) on the top, rear of the SCCM. Do not remove the fastener completely (Figure 2).

9. Loosen the clamp fastener (2) to allow the SCCM to be removed. Do not remove the fastener completely (Figure 2).

10. Pull the SCCM (3) away from the steering column inner shroud far enough to disconnect the instrument panel wire harness connectors (Figure 2).

11. Remove the SCCM from the steering column.

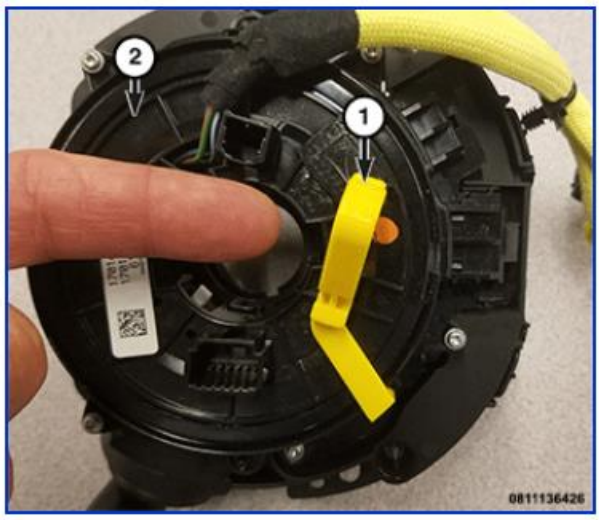
Figure 3 - SCCM

1 - Lock
2 - Clockspring Rotor

- A service replacement SCCM is shipped with the clockspring centered and with a molded plastic lock (1) installed. This lock should not be broken off until the SCCM has been installed on the steering column (Figure 3).
- Tighten the fasteners securely.
- Engage the integral inner shroud retainers with the SCCM. Be certain all integral inner shroud retainers are engaged with the SCCM.
- If a new SCCM is being installed, break off the plastic lock (1) that secures the clockspring rotor (2) to the SCCM housing to maintain clockspring centering (Figure 3).

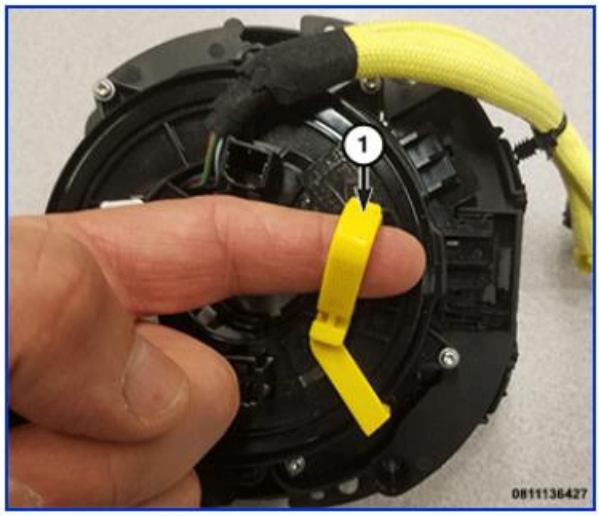
Figure 4 - SCCM Lock

1 - Lock

- Rotate the lock (1) towards the center of the SCCM to break it off in the SCCM housing (Figure 4).

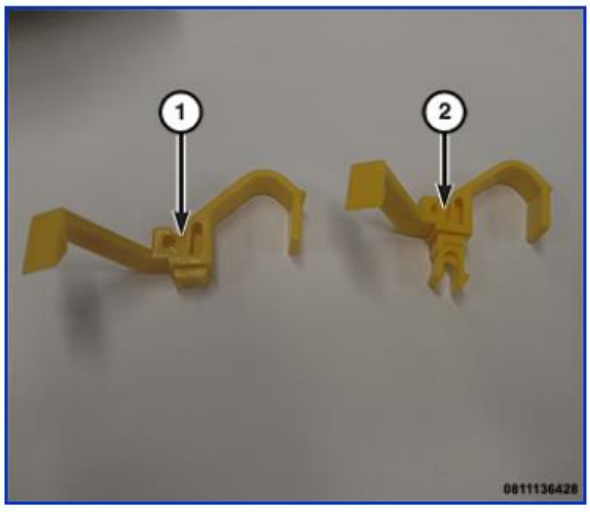
Figure 5 - SCCM Locks

1 - Lock Legs Broken Properly
2 - Original Lock

- When the lock has been broken off properly, both legs will be missing (1) when compared to the original lock (2) (Figure 5).
- Tighten the **NEW** steering wheel nut to 45 N·m (33 ft. lbs.).
- After installation of the air bag, but before reconnecting the battery negative cable, perform the Supplemental Restraint System Verification Test. In Service Library refer to 10 - Restraints / Standard Procedure / Supplemental Restraint System Verification Test.
