STAR ONLINE PUBLICATION

Case Number: S2308000159

Release Date: December 2023

Symptom/Vehicle Issue: Malfunction Indicator Lamp (MIL) on, Service 4WD System Message on the Cluster Display

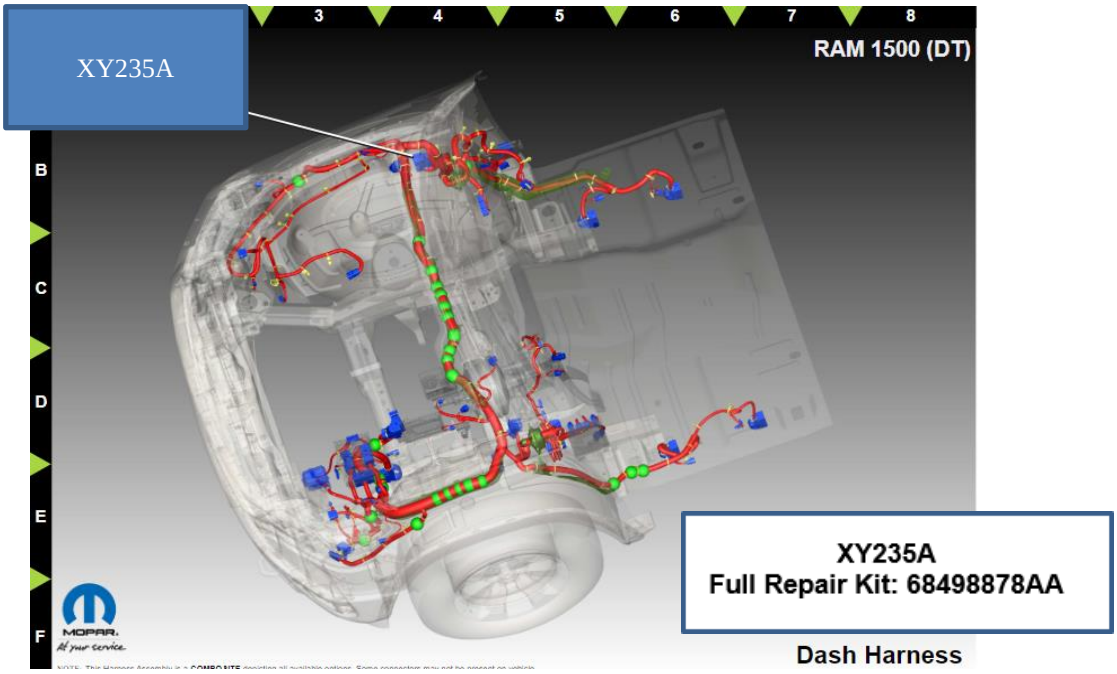
XY235A 48 -way grey connectorXY235A

Customer Complaint/Technician Observation: Owner complains of a Mil on and/or a Service 4wd message appearing on the cluster. Technician observed the vehicle may have set any of the following Diagnostic Trouble Codes (DTCs): P2008, C140A, C1406, C1406, P258B, C1252, P1004, P2017, U0120, U0158, U1817 or CAN C Bus U0001-00.

Repair Procedure: Inspect the Grey 48-way connector, passenger side engine compartment. Inspect for signs of water intrusion and or corrosion, pushed out or spread terminals. Repair or replace the terminals as needed.
