STAR ONLINE PUBLICATION

Case Number: S1923000052 Rev.C

Symptom/Vehicle Issue: Wind Noise From Lower Center Windshield Area At Highway Speed

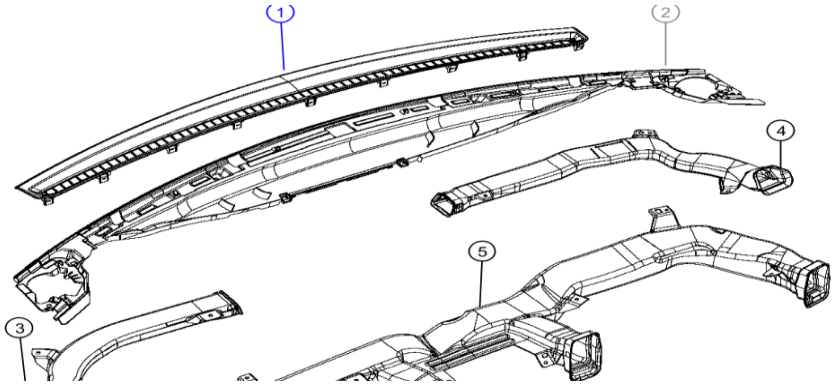
Discussion: Isolate the noise location with chassis ears, stethoscope or a simple stethoscope made from a 3' piece of heater hose held to your ear and the other moved to source the noise location. If the noise is around the upper dash windshield, remove the trim to inspect the bolt locations shown below. A missing fastener can cause wind noise.

To access the area using a trim stick remove item #1 Cowl Top Cap.

Fastener part number 06100567 attaches the upper dash to the body at the windshield.

Verification: Test drive to confirm repair.
