SAFETY RECALL
INTERNATIONAL
8HP75 TCU Weld

Reference: 63B

FCA US LLC

2023 (DT) Ram 1500 Pickup
2023 (DJ) Ram 2500 Pickup
2023 (D2) Ram 3500 Pickup
2023 (DD) Ram 3500 Cab Chassis

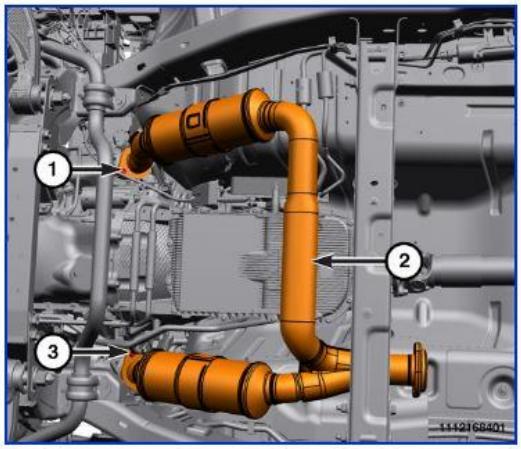
Figure 1 – Exhaust Bolts

6. Remove the left and right catalytic converter to exhaust manifold bolts (1,3) (Figure 1).
7. Remove the two nuts securing the Y-pipe to the exhaust system.
8. Reposition the exhaust Y-pipe out of the way.
9. Drain the transmission fluid (Refer to 21 - Transmission and Transfer Case/Automatic – 8HP75/FLUID and FILTER/Standard Procedure).

1 - Left Catalytic Converter To Exhaust Manifold Bolts
2 - Catalytic Converter
3 - Right Catalytic Converter To Exhaust Manifold Bolts

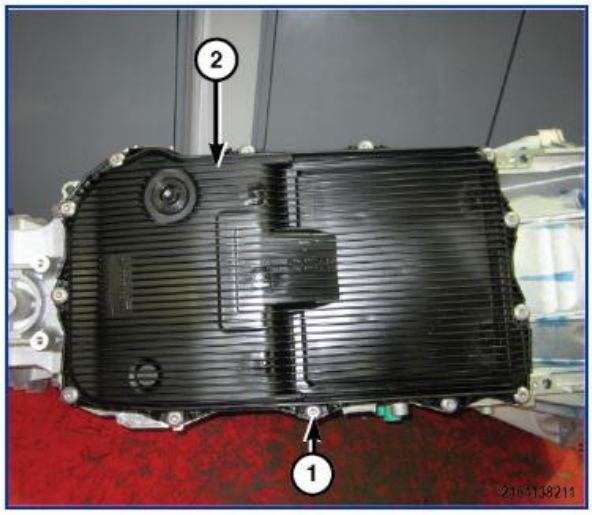
Figure 2 – Harness Connector

10. Disconnect the transmission wire harness connector (1) from the transmission by rotating the connector counter-clockwise (Figure 2).

1 - Transmission Wire Harness Connector

17. Connect the transmission wire harness connector (1) (Figure 2).
18. Turn the locking mechanism of the transmission wire harness connector clockwise to lock it in place.

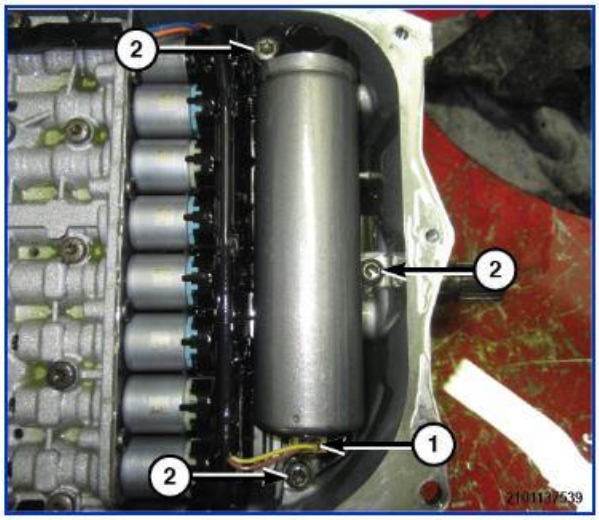
Figure 4 – HIS Connector and Bolts

13. If equipped, disconnect the Hydraulic Impulse Solenoid (HIS) wire harness connector (1) (Figure 4).

14. If equipped, remove and the three HIS bolts (2) and remove the HIS accumulator (Figure 4).

1 - Hydraulic Impulse Solenoid (HIS) Wire Harness Connector
2 - HIS Bolts

12. If equipped, install the **NEW** HIS accumulator.
13. Tighten the **NEW** HIS bolts (2) to 8 N·m (71 in. lbs.) (Figure 4).
14. Connect the HIS wire harness connector (1) (Figure 4).

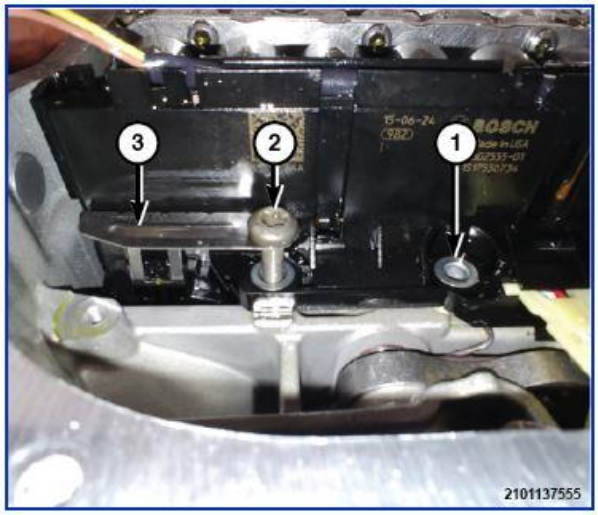
Figure 5 – Valve Body End Bolts and Connector Lock

15. Remove the valve body assembly end retainer bolts (1, 2) (Figure 5).

16. Lift the electrical connector lock (3) to release the internal harness end from inside the transmission for valve body assembly removal (Figure 5).

1 - Valve Body Assembly End Retainer Bolt
2 - Valve Body Assembly End Retainer Bolt
3 - Electrical Connector Lock

NOTE: Check that the manual park release lever is aligned.
3. Use an appropriate tool on one of the alignment pins to assist in holding the valve body in position while installing the remaining fasteners.
4. Install the **NEW** valve body assembly retaining bolts 1-14 and hand tighten the valve body bolts (Figure 9).
5. Remove the pins and install the remaining bolts.
6. Using the Remover/Installer, Guide Sleeve 10377 carefully install the transmission harness guide sleeve to the transmission case (Figure 7).
7. Push the wire harness connector lock down to lock it to the internal wire harness connector end and install the **NEW** valve body end retaining bolts (Figure 5).

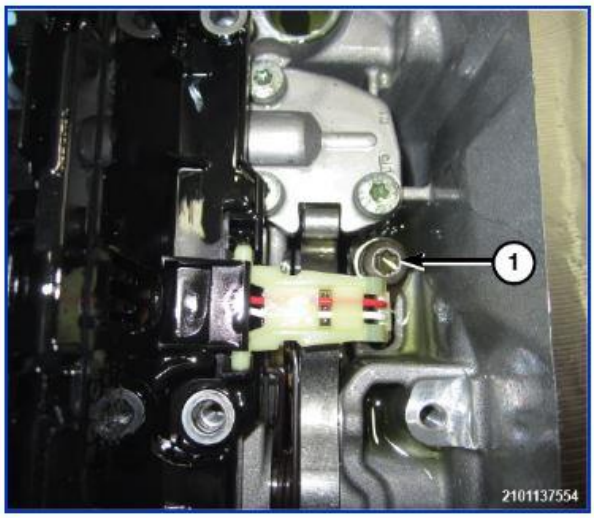
Figure 6 – OSS Bolt

17. Remove the Output Speed Sensor (OSS) bolt and pull the sensor loose from the case (Figure 6).

1 - Output Speed Sensor (OSS) Bolt

10. Install the OSS and install the **NEW** OSS bolt and tighten to 8 N·m (71 in. lbs.) (Figure 6)
11. Tighten **ALL** of the valve body bolts to 8 N·m (71 in. lbs.) in the sequence shown (Figure 9).

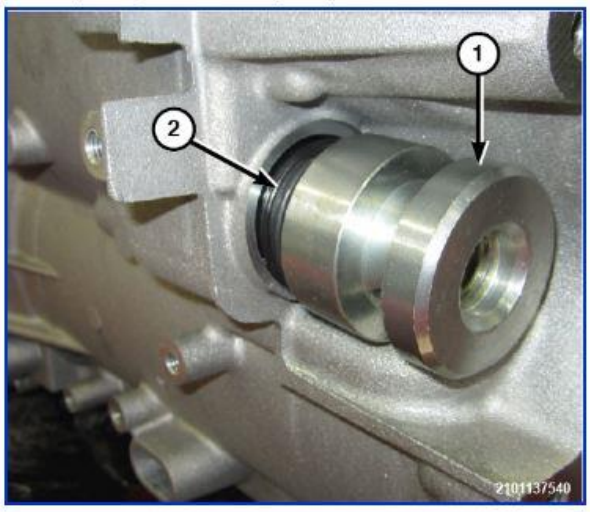
Figure 7 – Guide Sleeve Removal and Installation

18. Using the Remover/Installer, Guide Sleeve 10377, pull the transmission harness guide sleeve straight out from the transmission case (Figure 7).

1 - Remover/Installer, Guide Sleeve 10377
2 - Transmission Harness Guide Sleeve

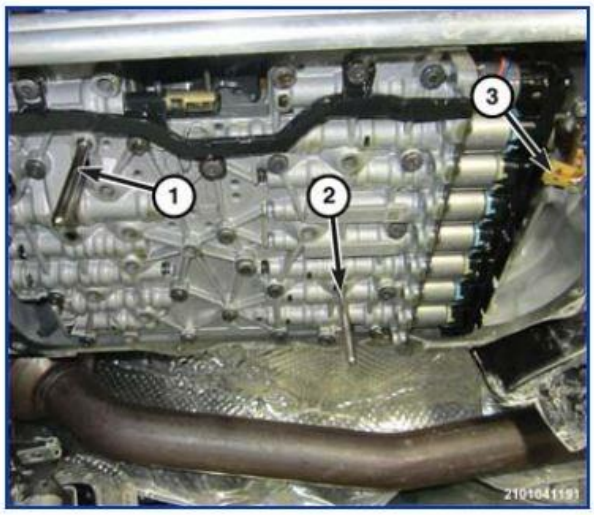
Figure 8 – Valve Body Alignment Pins

20. Remove two valve body assembly retaining bolts in the positions shown and hand install the Pins, Valve Body Alignment 10379 (1,2) (Figure 8).

1 - Pin, Valve Body Alignment 10379
2 - Pin, Valve Body Alignment 10379
3 - Output Speed Sensor (OSS) Wire Harness Connector

1. Install the fluid transfer port with **NEW** O-rings (Figure 10).
2. Install the **NEW** valve body assembly to the transmission using the previously installed Pins, Valve Body Alignment 10379 as a guide (Figure 8).

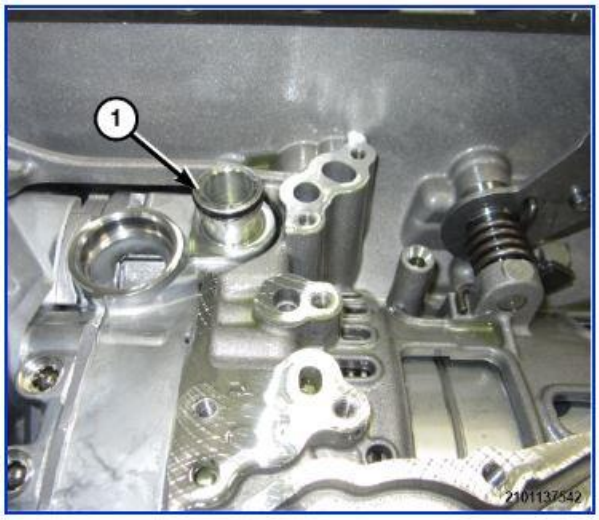
Figure 9 – Valve Body Bolts

22. Remove remaining valve body assembly retaining bolts in the order shown (Figure 9).

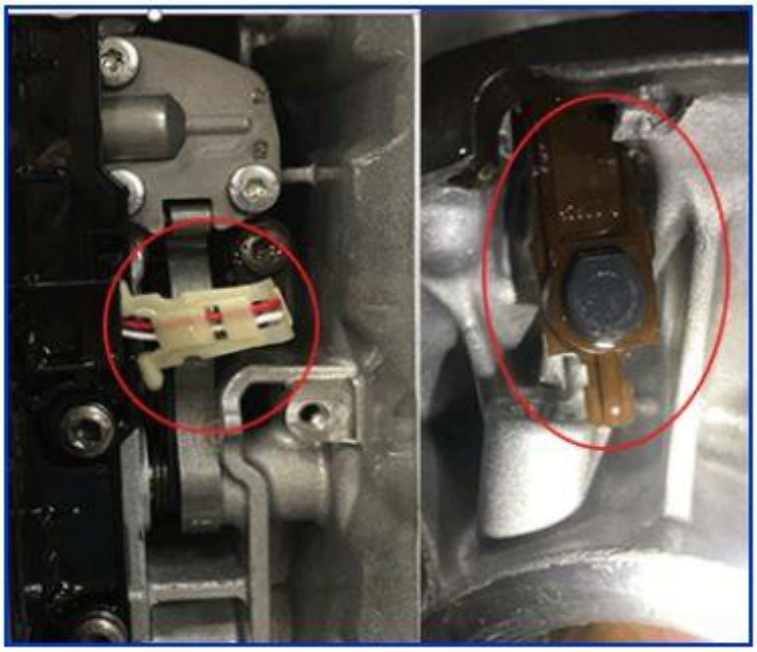
Figure 11 – Incorrect Alignment of OSS Pin

8. When installing the OSS into the case, take care to position the OSS guide pin as shown below or **DAMAGE** to the sensor may result. This is the **INCORRECT** alignment of the pin (Figure 11).

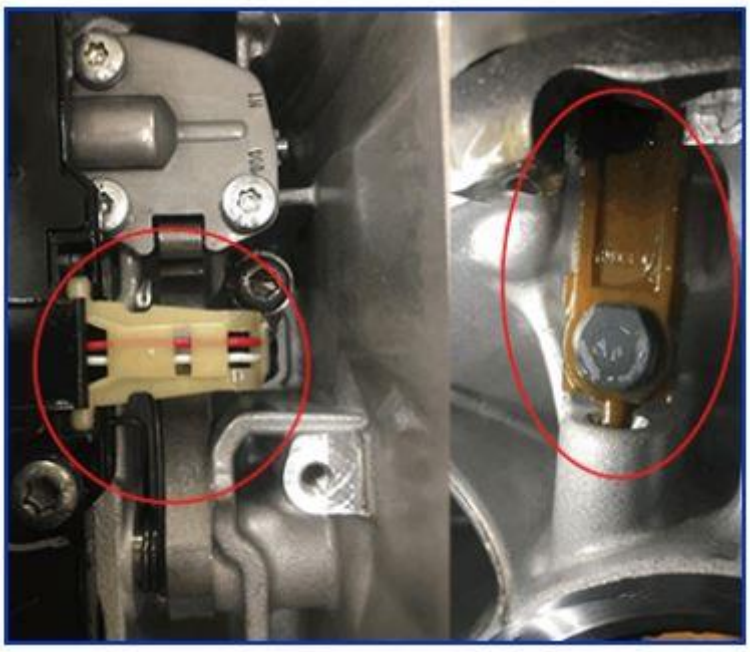
Figure 12 – Correct Alignment of OSS Pin

9. This is the **CORRECT** installation and pin alignment (Figure 12).

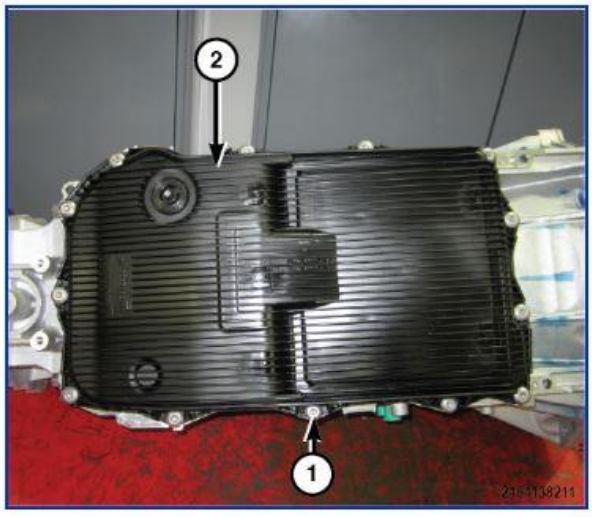
Figure 15 – Transmission Oil Pan Bolts

7. Remove the transmission oil pan bolts (1) (Figure 15).

8. Remove the transmission oil/filter pan assembly (2) and gasket (Figure 15).

1 - Transmission Oil Pan Bolts
2 - Transmission Oil/Filter Pan Assembly

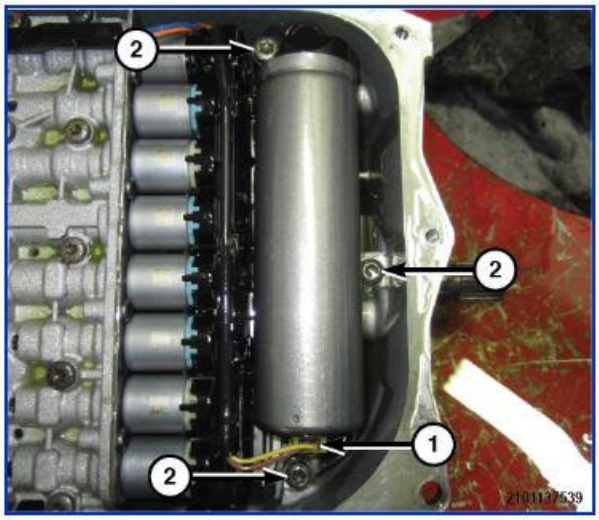
Figure 16 – HIS Connector and Bolts

9. If equipped, disconnect the Hydraulic Impulse Solenoid (HIS) wire harness connector (1) (Figure 16).

10. If equipped, remove and the three HIS bolts (2) and remove the HIS accumulator (Figure 16).

1 - Hydraulic Impulse Solenoid (HIS) Wire Harness Connector
2 - HIS Bolts

33. If equipped, install the **NEW** HIS accumulator.
34. Tighten the **NEW** HIS bolts (2) to 8 N·m (71 in. lbs.) (Figure 16).
35. Connect the HIS wire harness connector (1) (Figure 16).

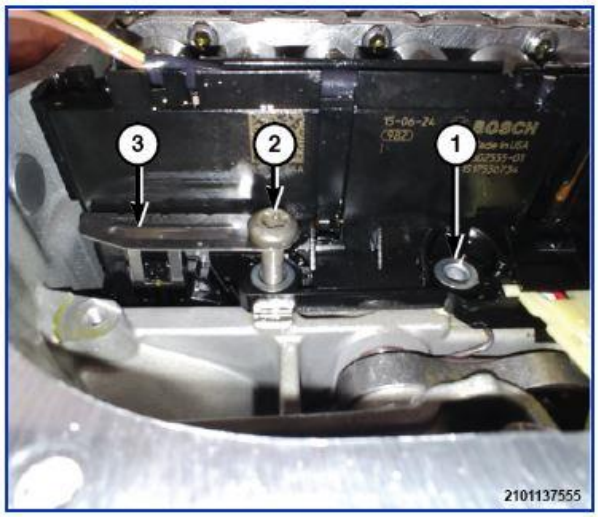
Figure 17 – Valve Body End Bolts and Connector Lock

11. Remove the valve body assembly end retainer bolts (1, 2) (Figure 17).

12. Lift the electrical connector lock (3) to release the internal harness end from inside the transmission for valve body assembly removal (Figure 17).

1 - Valve Body Assembly End Retainer Bolt
2 - Valve Body Assembly End Retainer Bolt
3 - Electrical Connector Lock

NOTE: Check that the manual park release lever is aligned.
24. Use an appropriate tool on one of the alignment pins to assist in holding the valve body in position while installing the remaining fasteners.
25. Install the **NEW** valve body assembly retaining bolts 1-14 and hand tighten the valve body bolts (Figure 21).
26. Remove the pins and install the remaining bolts.
27. Using the Remover/Installer, Guide Sleeve 10377 carefully install the transmission harness guide sleeve to the transmission case (Figure 19).
28. Push the wire harness connector lock down to lock it to the internal wire harness connector end and install the **NEW** valve body end retaining bolts (Figure 17).

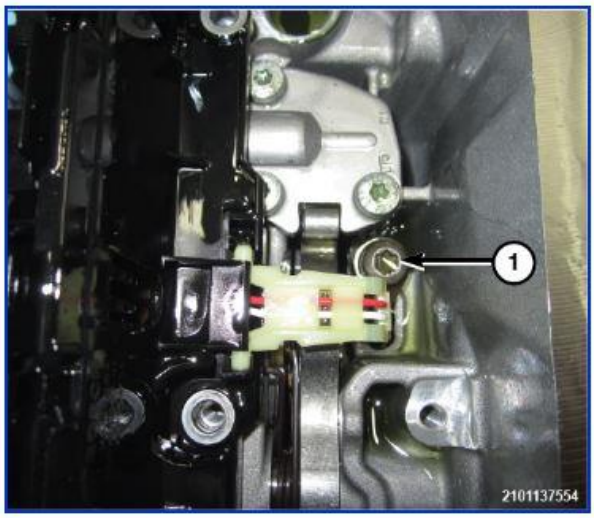
Figure 18 – OSS Bolt

13. Remove the Output Speed Sensor (OSS) bolt and pull the sensor loose from the case (Figure 18).

1 - Output Speed Sensor (OSS) Bolt

31. Install the OSS and install the **NEW** OSS bolt and tighten to 8 N·m (71 in. lbs.) (Figure 18)
32. Tighten **ALL** of the valve body bolts to 8 N·m (71 in. lbs.) in the sequence shown (Figure 21).

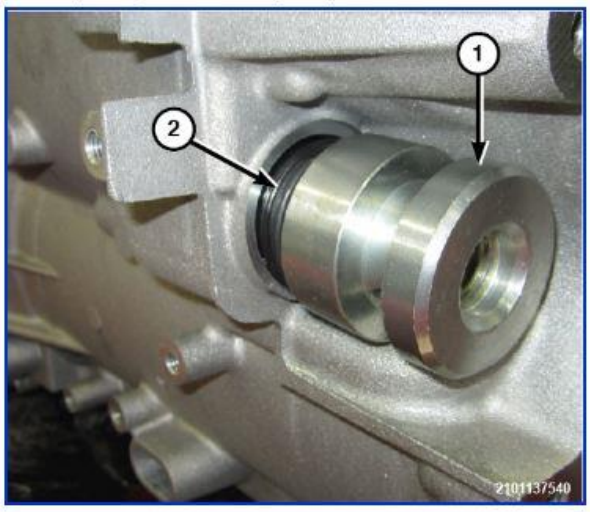
Figure 19 – Guide Sleeve Removal and Installation

14. Using the Remover/Installer, Guide Sleeve 10377, pull the transmission harness guide sleeve straight out from the transmission case (Figure 19).

1 - Remover/Installer, Guide Sleeve 10377
2 - Transmission Harness Guide Sleeve

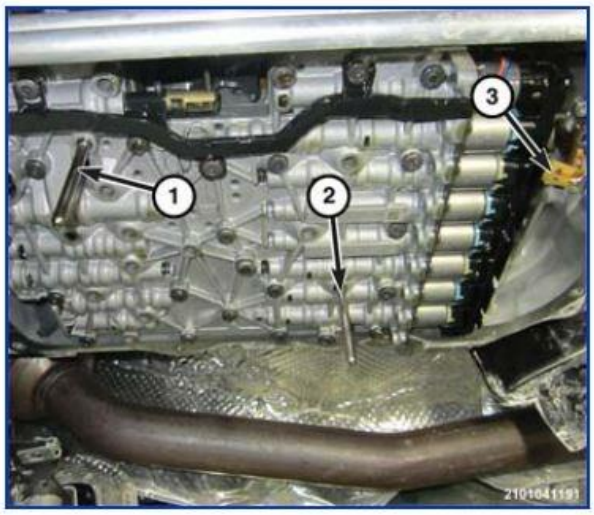
Figure 20 – Valve Body Alignment Pins

16. Remove two valve body assembly retaining bolts in the positions shown and hand install the Pins, Valve Body Alignment 10379 (1,2) (Figure 20).

1 - Pin, Valve Body Alignment 10379
2 - Pin, Valve Body Alignment 10379
3 - Output Speed Sensor (OSS) Wire Harness Connector

22. Install the fluid transfer port with **NEW** O-rings (Figure 22).
23. Hold the **NEW** valve body up while an assistant installs the Pins, Valve Body Alignment 10379 as a guide (Figure 20).

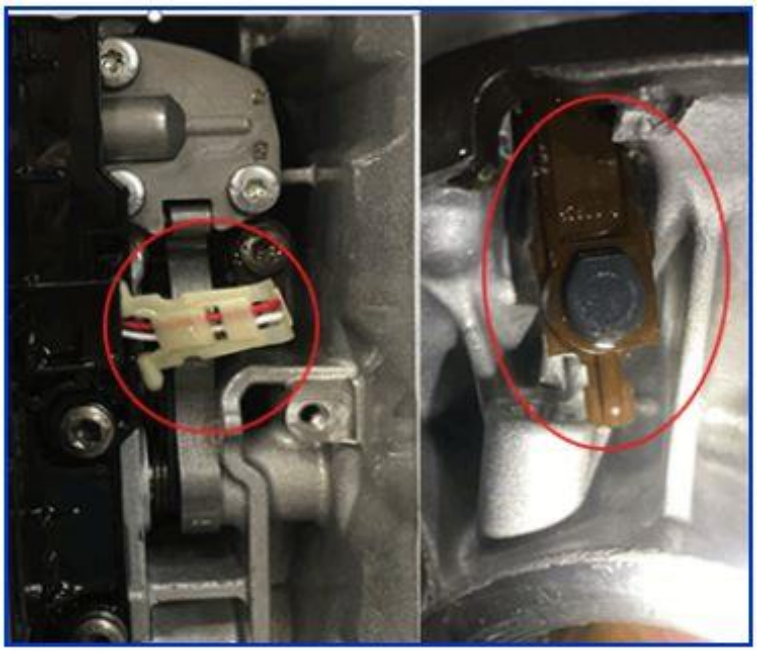
Figure 23 – Incorrect Alignment of OSS Pin

29. When installing the OSS into the case, take care to position the OSS guide pin as shown below or **DAMAGE** to the sensor may result. This is the **INCORRECT** alignment of the pin (Figure 23).

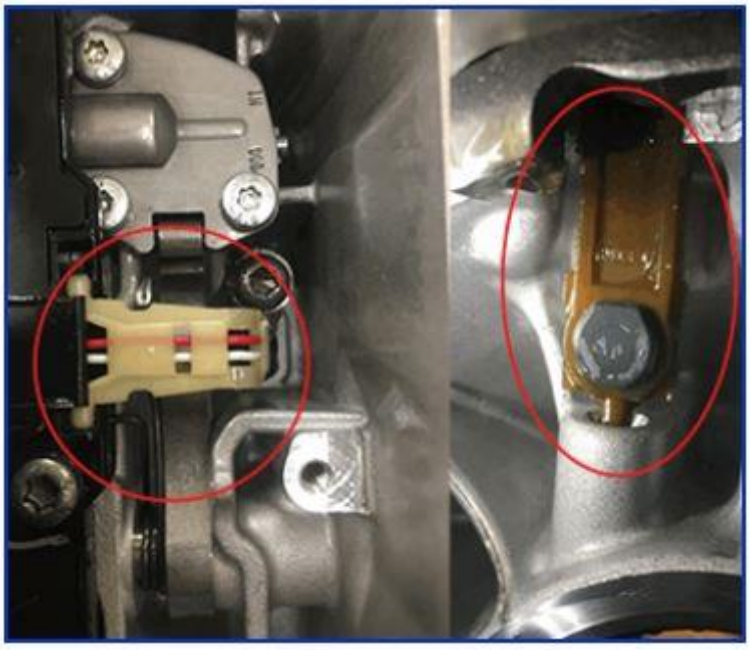
Figure 24 – Correct Alignment of OSS Pin

30. This is the **CORRECT** installation and pin alignment (Figure 24).
